**KENTUCKY CAMP**  
**ASSAY BUILDING**  
**INTERIOR DOCUMENTATION**

For the Coronado National Forest  
Tucson, Arizona

November, 2004

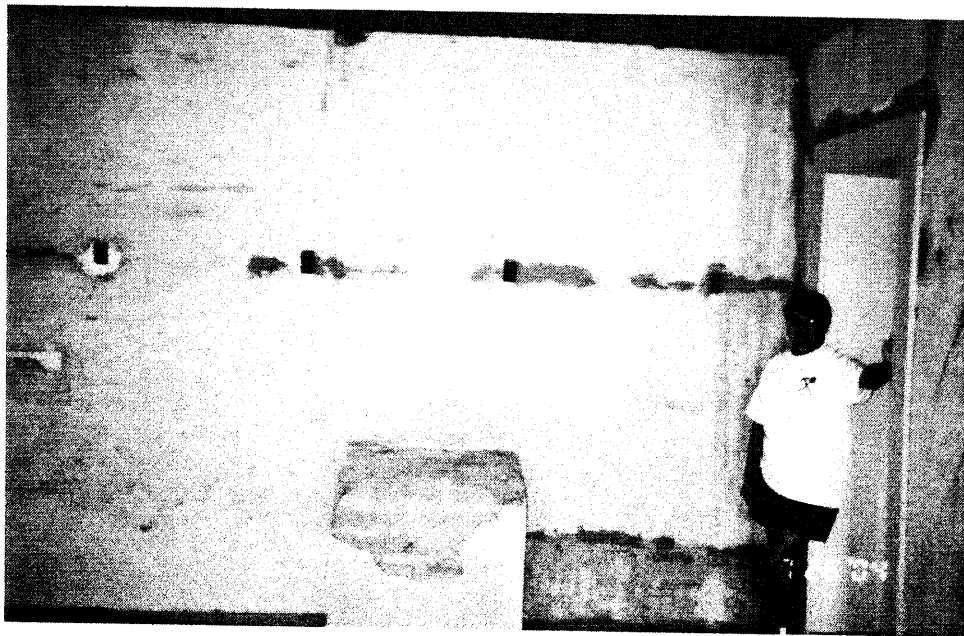
Based on comparing the wall condition today to the 1992 P.I.T. scale drawings very little has changed. However, the pedestal built against the wall has suffered loss of plaster from the top and a portion of the front face. Most likely this damage was caused by people hitting it and piling various items of construction material on top of it.

Except for a small piece at the back left corner, all the plaster has broken off the pedestal top exposing the adobe bricks that make up the top course (Figure 16 & 17). This small remaining top piece shows that a thin layer of cement plaster was applied over lime. The exposed top revealed that four bricks each measuring 18 x 12 inches were used to form each course. The four bricks were laid in a pattern that left a center hole which was then filled with adobe mud. There is still patches of lime plaster seen on the top of the pedestal covering portions of the adobe bricks. It appears the entire top may have been lime plastered and then a thin cement plaster applied over the lime.

Approximately half of the plaster on the pedestal front has broken off. Based on the exposed courses, the pedestal was seven courses high. Between each course there is lime mortar which would, at first glance make one assume that the bricks were laid in lime mortar. However, based on close examination of the top course it is obvious that only the outside edges of the joints were filled with lime and that the remainder was mud filled (Figure 17). Why would they use lime in these mortar joints? One scenario might be that the lime was used to fill the outer voids in the mud mortar joints to form an anchor for the cement plaster. Since cement is not as compatible with adobe as it is with lime, the cement would hold to the lime better than to the adobe. The three exposed sides of the pedestal have a thin layer of cement plaster (Munsell - 5Y 7/1, light gray) over the adobe bricks and lime mortar joints. The fourth side was built against the west wall but it is now separating from the wall. At the top there is a gap measuring between 3/8 to 1/2 inch wide the entire width of the pedestal.

**Figure 1** - Pedestal built against the west wall of Room E-2. Note the four 2 x 4 "gringo boards" seen just above head height. Marie Britton is standing in the doorway to Room E-1.

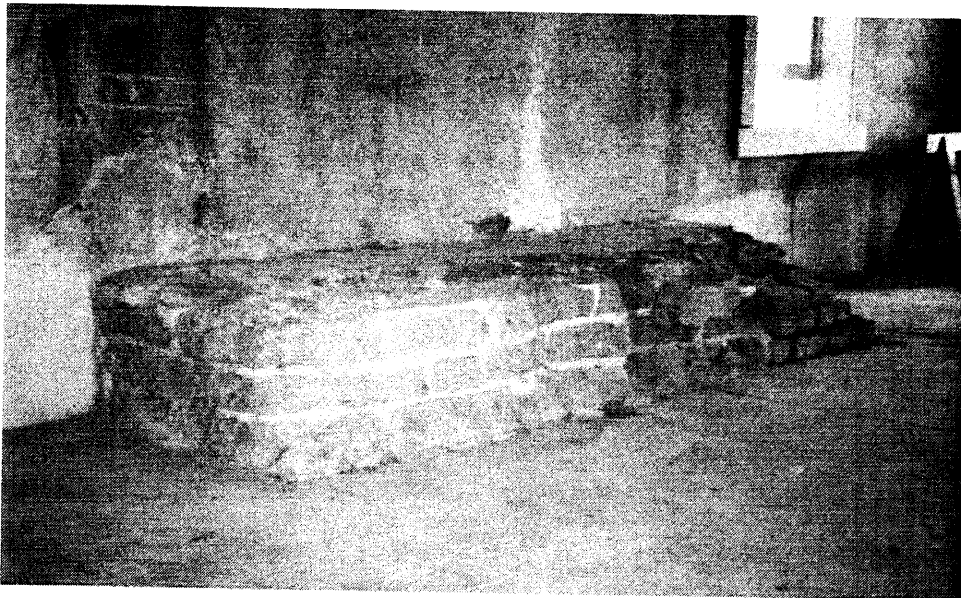
The lime plaster above the platform is in relatively good condition. There is one crack that runs from the top of the platform to the ceiling. As is the case in all of the other walls in this room, this wall has deteriorated or missing plaster on the three bottom courses. New plaster has been applied to these courses, but it has shrink cracks and should be removed and replastered.

There is some evidence that lime was used on top of the platform below the cement plaster. However, cement is seen directly on adobe bricks in some places. It may be that the builders only used the lime to fill in voids and help anchor the cement plaster. The cement plaster ranges from 1/4 to 1/2 inches thick. Most of the plaster on the back half of the platform is still present with cracks.

**Figure 2** - Platform built against the north wall in Room E-2. Adobe brick construction except for the red bricks at the east end. The bricks were laid with mud mortar. The lime mortar seen here is only at the edge of the mortar joint.

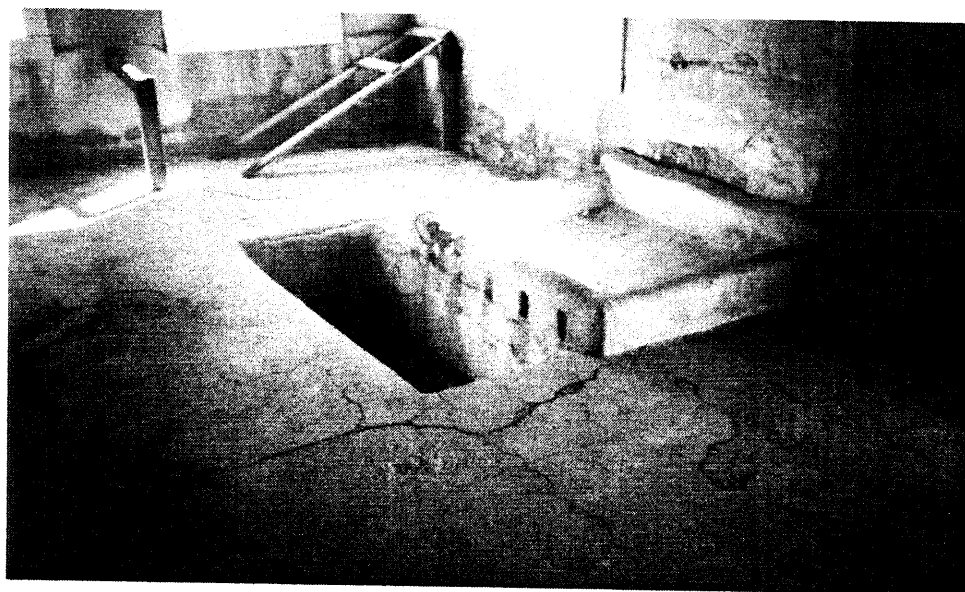
This is the only non-wood floor in any of the five buildings that make up Kentucky Camp. The floor is made of concrete which is approximately four inches thick. The measurement for this thickness was made at the square floor opening located near the south west room corner. A thin (approximately 1/4 inch) cement mortar cap was later applied over the concrete base. This thin layer is cracking and is missing in many places exposing the rough concrete surface below (Figure 3).

The entire concrete pan has detached from the wall leaving an open gap between it and the wall. This gap most likely was caused by erosion of the wall adobe.

Marks or impressions in the east and south walls indicate a shelf or bench top was in place prior to the wall being lime plastered. In Figure 3, a frame consisting of four boards can be seen. It is not long enough to span the entire distance between the supports. It therefore, may have been placed there by someone and not been used with the supports. The photo in Figure 3 was taken by Britton in February 1999. The frame work is now missing.

**Figure 3** - Five hole drain pan built against the south wall of Room E-2. A subsurface tub is located below to catch the over flow from the pan. In the background next to the east wall is the 2 x 4 supports for a shelf or bench. Note the concrete floor where the top thin smooth cement layer is chipping off.

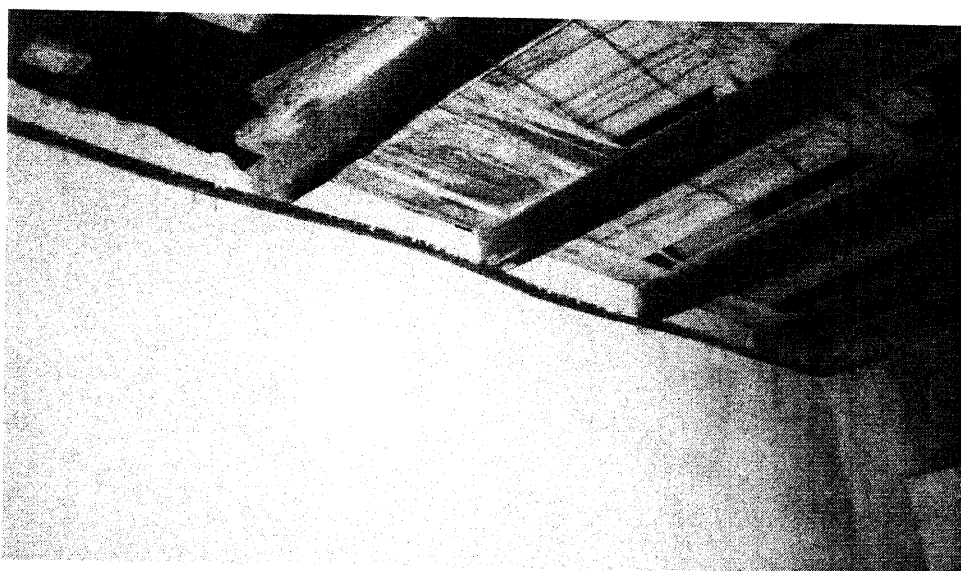
This room had a cloth ceiling. Thin narrow wood molding that held the manta cloth to the rafters are still present next to all four walls (Figure 4). With the manta material missing, the ceiling joists, rafters, stringers, and wood shingles can be seen from below. The original wood is an aged dark color while the replacement pieces put in place in 1991 are a lighter color.

**Figure 4** - This shows the north wall of Room E-1 with the wood trim nailed to the bottom of the ceiling joist. This trim board was along all four walls and had been used to hold the manta cloth in place.

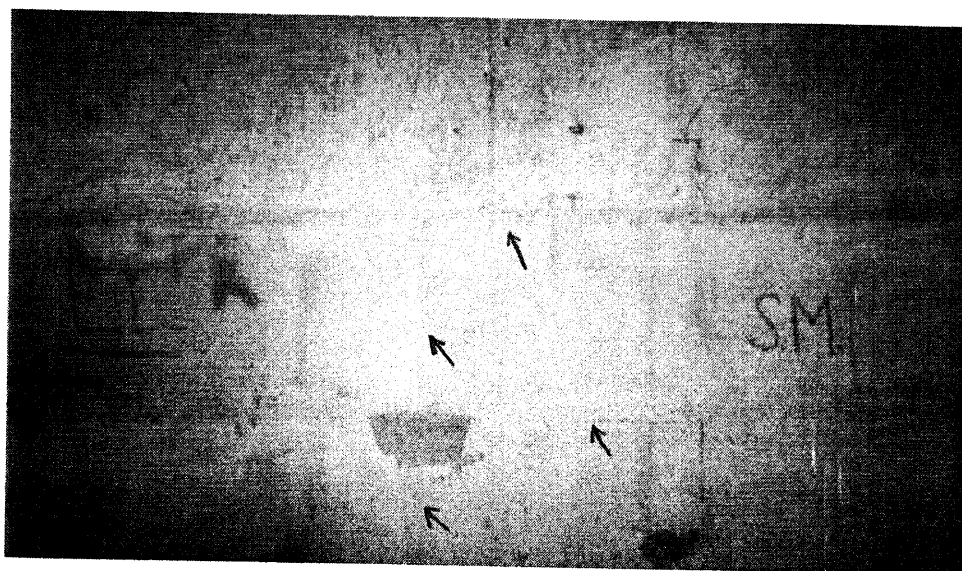
The wall surface between the horizontal shelf stripes is approximately 13 inches high. The exact measurement is varied due to the paint not being in a perfectly straight line. In some locations it appears that the paint may have ran behind the shelf where it made contact with the plastered wall surface. The area between these stripes is a dark shade of the gray color (5Y 7/1 on the Munsell Color Chart). The majority of the wall is a varied lighter shade of gray (Munsell Color Chart was 2.5Y N7/0). The extent of the varied lighter gray depends on it's exposure and wear. It can be assumed that whatever was stored on the shelves protected this area from fading. There are no holes in the darker area that would have indicated something had been nailed against adobe wall between the shelves.

**Figure 5** - The two horizontal lines and one vertical line near photo center are mud plaster color and indicate two shelves or something was against the wall before paint was applied. Initials are incised on each side of the center line.

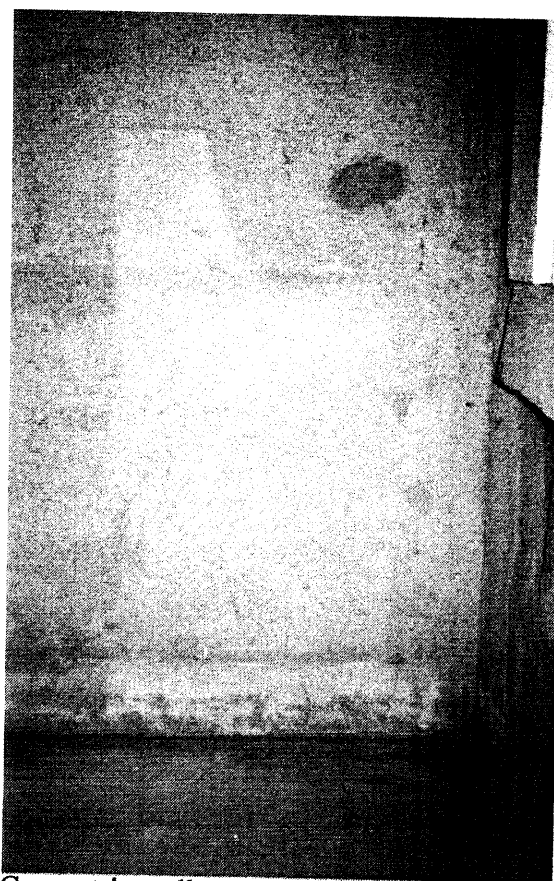
**Figure 6** - Geometric wall pattern seen on the north wall of Room E-1. The wood on the right is part of the east wall window.

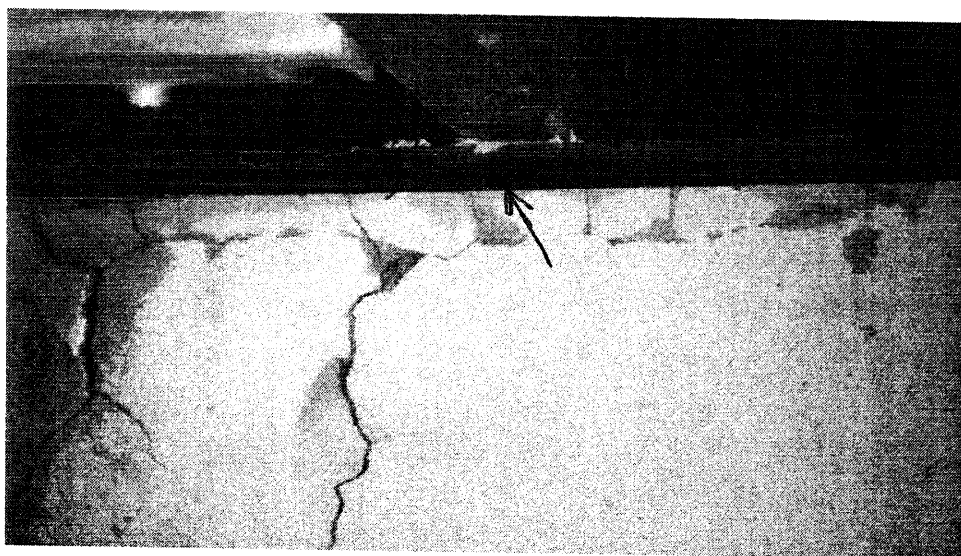
**Figure 7** - The piece of white material seen in this photo, between the trim board and the ceiling joist of Room E-1, is a small piece of manta cloth. The cloth was used as a ceiling in place of wood boards.

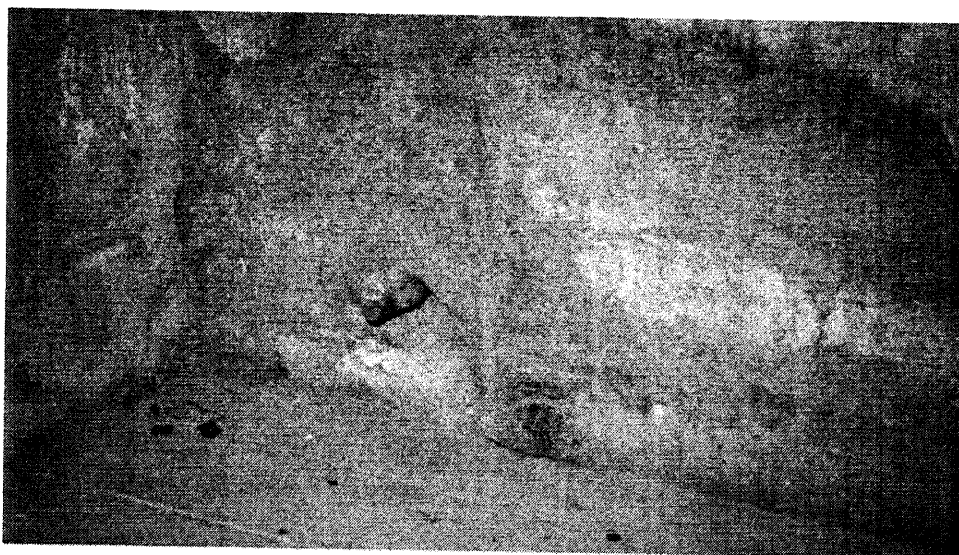
**Figure 8** - This pipe located near the south east corner extends 5 1/2 inches into Room E-1. The other end of the pipe is embedded in the cement feature in the platform shown in Figure 9.

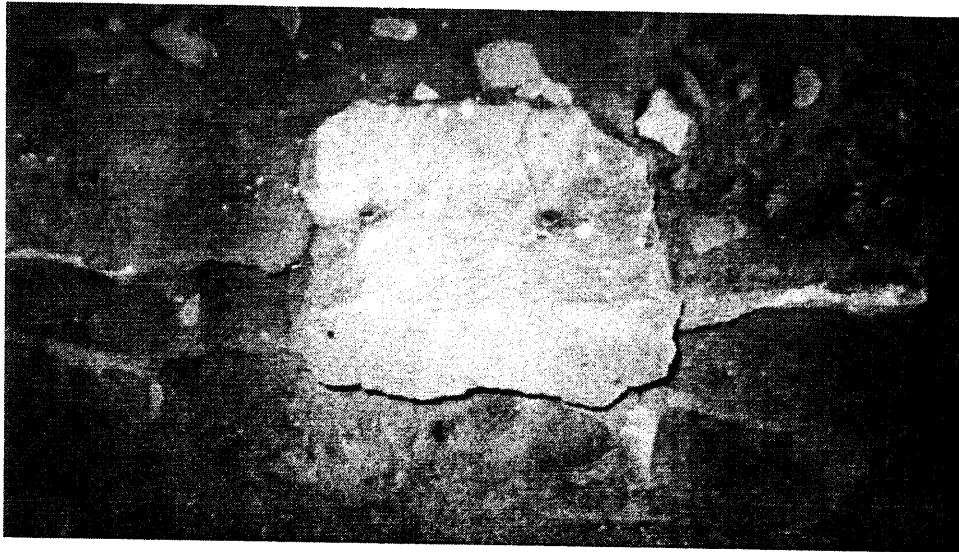
**Figure 9** - This cement feature is located in the platform in Room E-2. Two pipes are seen embedded in the cement. The left one extends through the platform and north wall and extends into Room E-1.

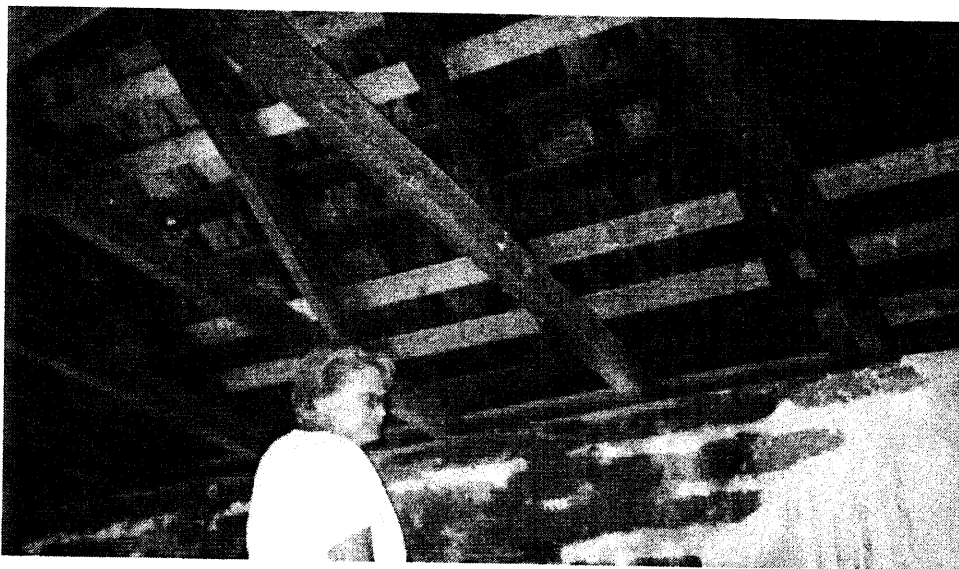
The missing or damaged roof components were replaced in 1991 by Forest Service personnel. The original wood is an aged dark color while the replacement pieces are a light color (Figure 10). There is no evidence, such as nail holes in the bottom of the original ceiling joists, to suggest that there ever was a closed ceiling. The rafters, ceiling joists, stringers, and wood shingles can be seen from below.

**Figure 10** - This photo shows the roof material at the south wall of Room E-2. The original wood is dark in color due to age while the replacement pieces are a light color.

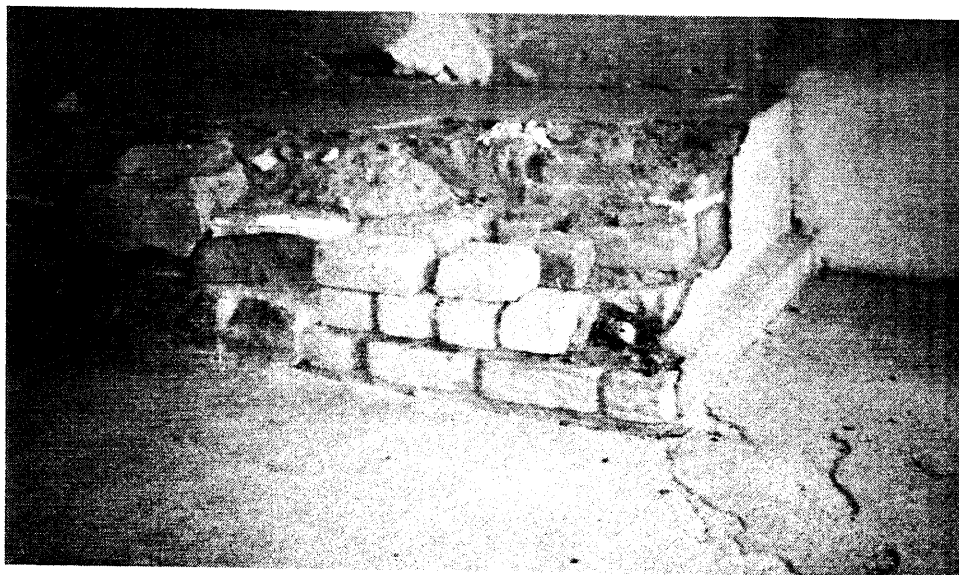
The platform is located 38 1/2 inches east of the door way to Room E-1 and 8 feet 6 inches west of the north east corner. It extends 8 feet 5 inches along the north wall when measuring at the top. At the bottom it is 8 ft 7 inches long due to a 2 inch angled base at the east end. The angle is caused by the bottom course extending 2 inches beyond the courses above (Figure 11). The west end has a vertical face. At the east end, against the north wall where all the cement plaster is still intact, the height is 15 inches. The platform depth from the front face to the north room wall is approximately 34 inches. There is a gap between the platform and the wall of approximately 5/8 inches along the entire length.

**Figure 11** - The platform is 2 inches longer at the bottom than the top. This difference is due to the bottom course of red bricks as shown in this photo. The red brick section is 27 inches across at the bottom course.

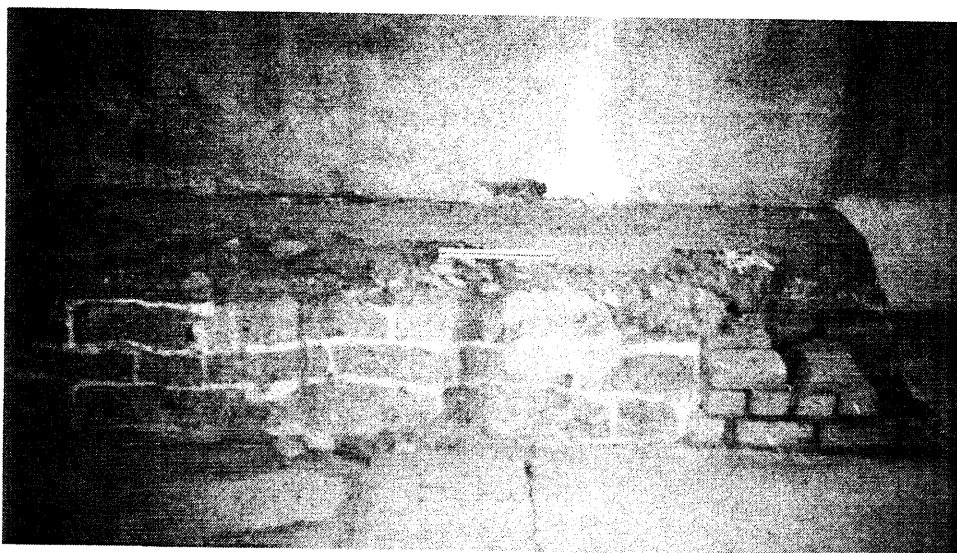
**Figure 12** - This photo shows the 8 feet 7 inch length of the platform located along the north wall of Room E-2. The red brick section can be seen on the right side. Only about half the top cement plaster is still in place.

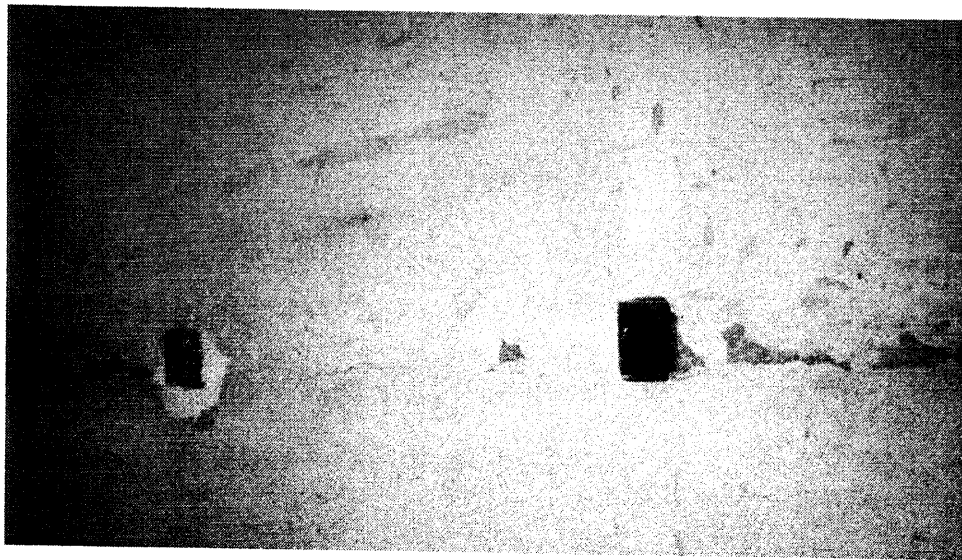
along this wall, are as follows: south west corner to first one is 1' 6 3/4", then 2' 11 1/8", then 2' 11 3/8", then 3' 1/2", and then 1' 1 1/2" to the north west corner. An irregular plaster line runs between each gringo board (Figures 13 & 14). This line is caused by missing or overlapping lime plaster episodes. Britton feels the overlapping pattern of the plaster line suggest the following sequence of construction:

**Figure 13** - The ends of two of the four 2 x4 gringo boards located along the west wall of Room E-2. A 2 x4 had been nailed to these ends. The "plaster line" seen between each was caused by not being able to apply the plaster behind the 2 x4 that extended across the entire wall.

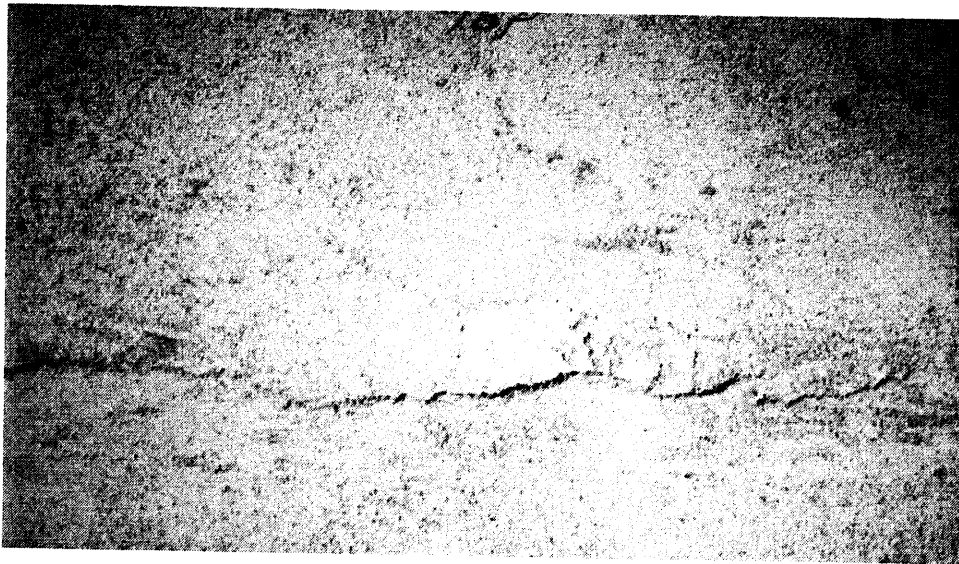
**Figure 14** - This is a close up of the "plaster line" that appears between each of the four 2 x 4 gringo boards along the west wall of Room E-2. The overlap of the plaster indicates that the area below the 2 x 4s was applied last.

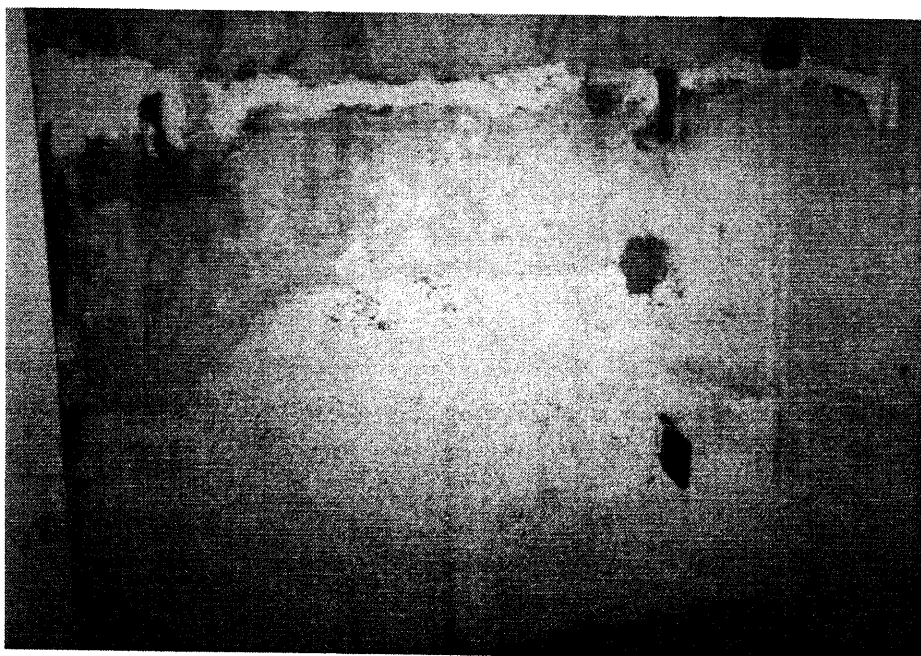
The west ends of two shelves constructed against the south wall abutted the west wall prior to lime plastering. This was determined by the top shelf leaving an indentation or impression in the plaster at the point of contact with the adobe bricks in this wall (Figure 15). The bottom indentation has been covered by lime plaster during previous repair of the basal erosion along this wall resulting in no evidence it ever existed. The top shelf impression was filled in with lime plaster which is very white in color, thus the impression pattern can be determined by the color contrast with the original darker plaster (5YR 8/2). If it wasn't for the single remaining gringo board, there would be no evidence that a second shelf ever existed.

**Figure 15** - This photo shows the south and west walls next to the corner of Room E-2. The white line is due to an application of new lime plaster it filled the shelf impression in the original plaster. The two dark slots in the line (see arrows) are holes of missing shelf supports. Only the bottom right shelf support remains. The bottom left hole has been plastered over.

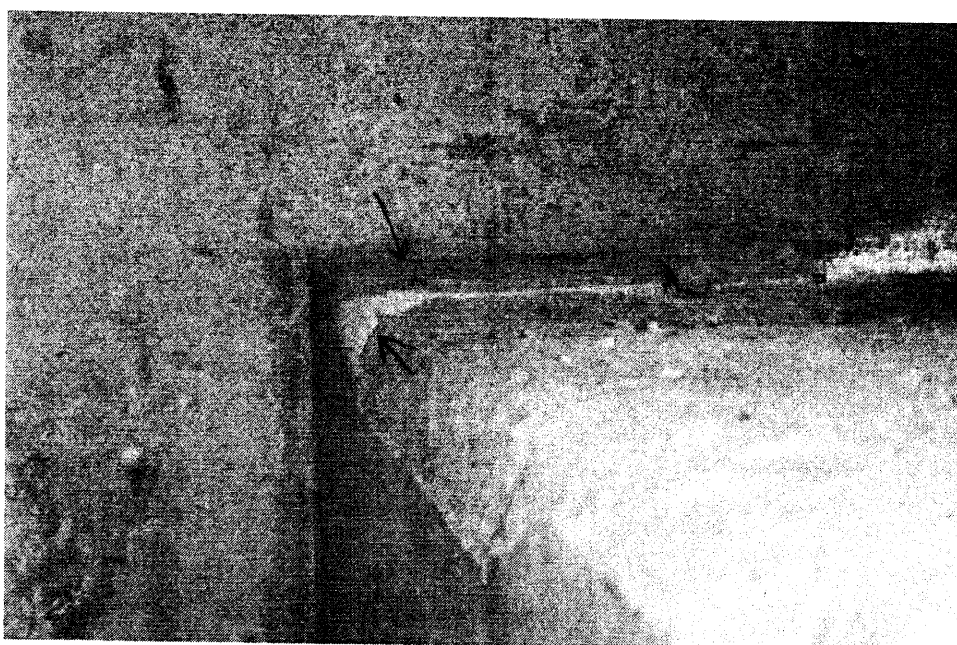
**Figure 16** - The only remaining original plaster on top of the adobe pedestal is at the back left corner and is shown in this photo. The top arrow points to the top cement (gray) coat while the bottom arrow points to the whitish lime coat.

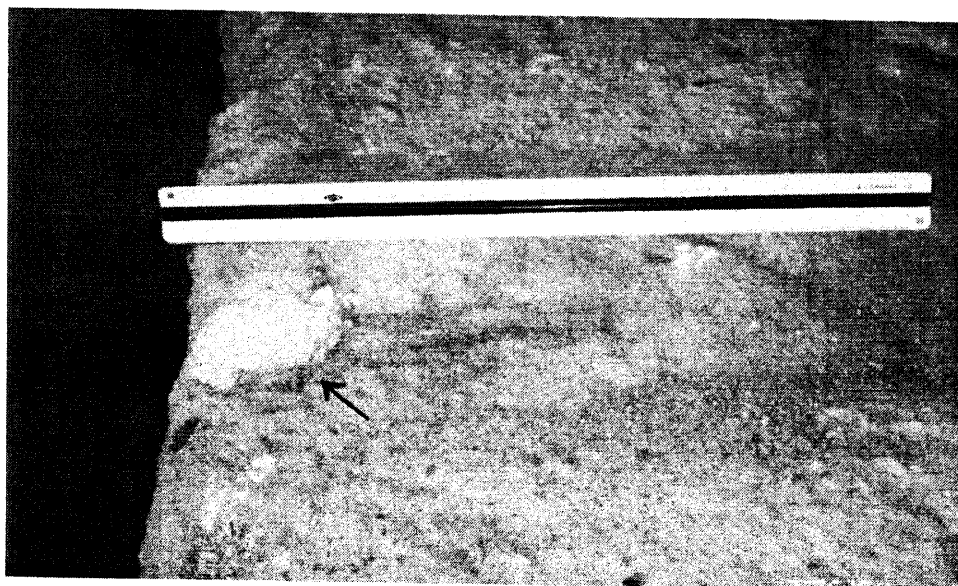
**Figure 17** - The top of the pedestal in Room E-2 was constructed with adobe bricks using mud mortar. The outside edge of the mortar joints have lime mortar as seen in this photo at the left edge. The total length of scale is 12 3/4 inches.

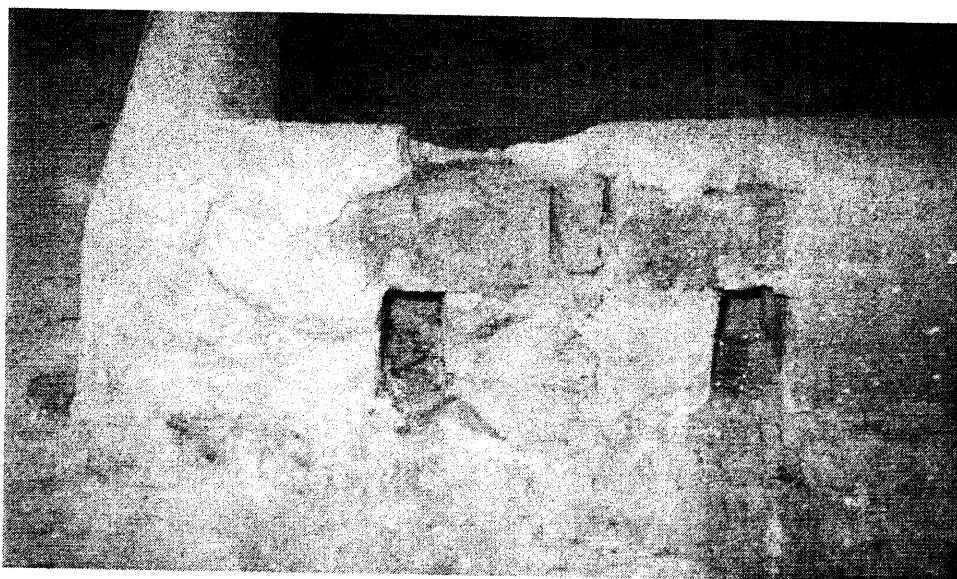
**Figure 18** - Two of the five drain holes in the processing pan are shown. These holes were formed around red bricks seen in here where the cement has broken off.

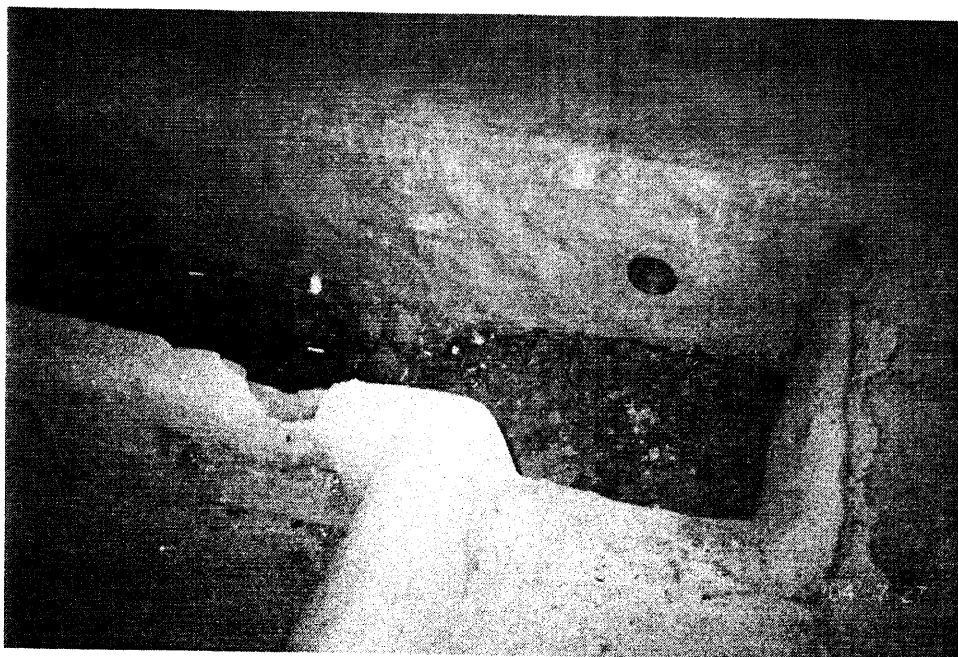
**Figure 19** - This view shows three of the drain holes in the pan and the subsurface tub below. The depth of the tub is not seen due to the dirt and stones. The pipe opening seen is the overflow which empties outside the building. (See Fig. 20).

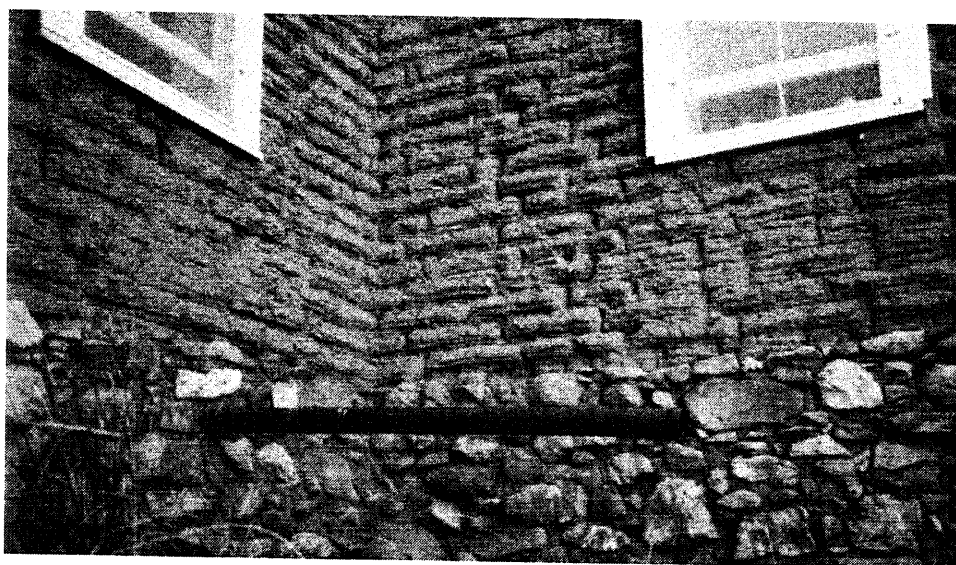
**Figure 20** - The tub drain pipe extends six feet beyond the exterior wall face of Room E-2.

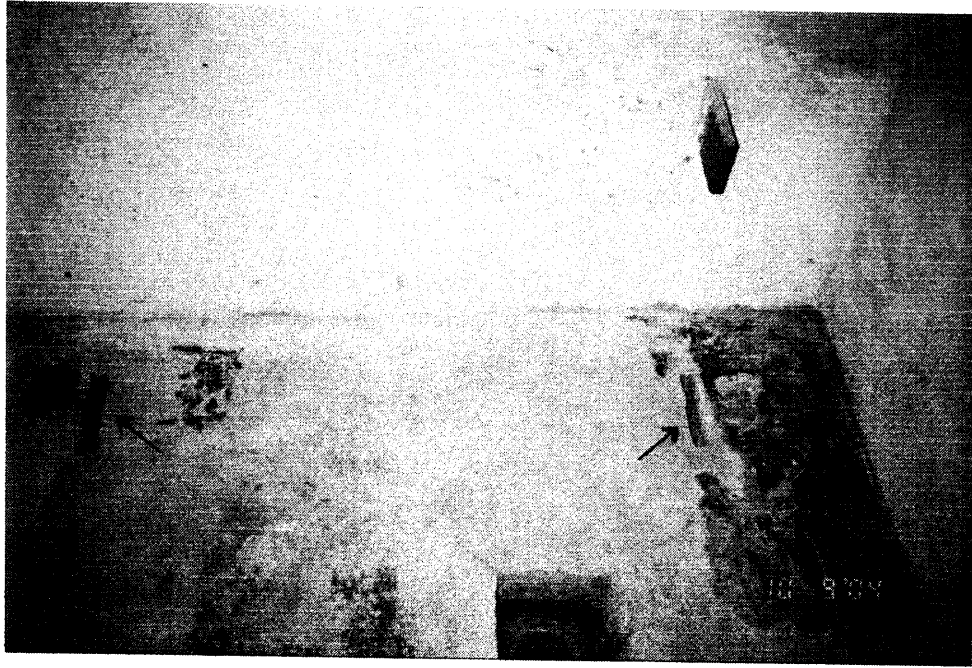
There are two rectangular holes in the floor concrete directly below where the gringo board shelf supports were located (Figure 21). These holes at first appeared to be only impressions in the concrete floor. However, while cleaning the dirt away it became apparent to Britton that there were still remnants of wood in the two holes. The hole nearest the door had wood broken into two pieces at the surface. He was able to remove the portion nearest the wall to get a depth measurement. The wood extended completely through the floor a distance of at least 5 inches below the floor surface.

**Figure 21** - The arrows point to two holes in the concrete floor which held the shelf support boards. This photo also shows the position relationship of the floor holes, the square hole in floor, and the only remaining wood shelf support in wall.

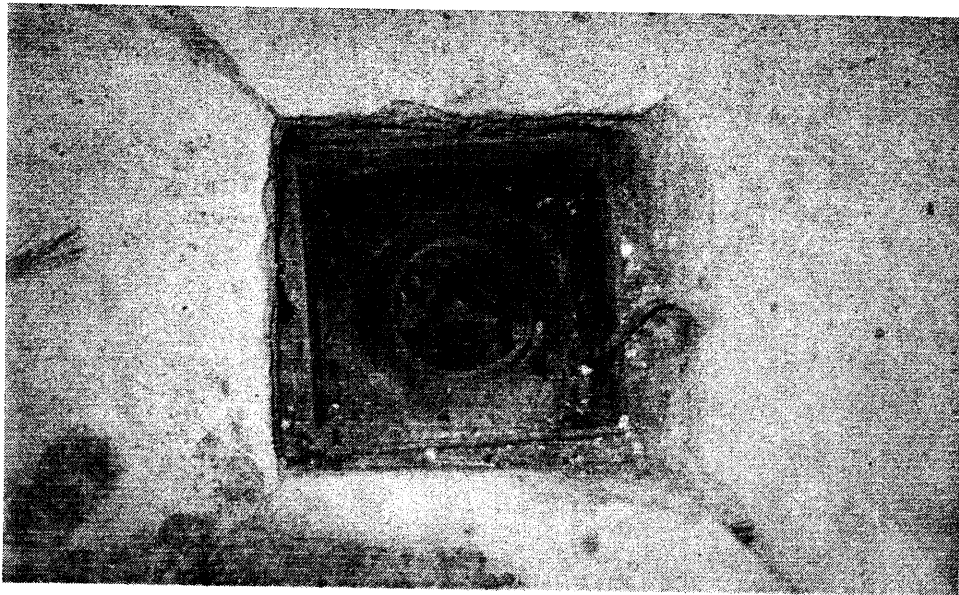
Britton using a 1/4 inch diameter metal probe, inserted it 23 inches straight down by pushing it with his hands and was not able to hammer it deeper. He also pushed and hammered the probe at an angle under each side of the metal plate. The probe penetrated at each angle meaning the hole widens under the plate and floor to some unknown distance. The plate was loose and could be removed, however a large bent nail had been set in concrete to apparently help hold the plate in position. Some type of equipment apparently had set over this opening.

**Figure 22** - The square hole in the floor of Room E-2 has a metal plate with a hole in its center. At the right side of the concrete hole is a large nail which apparently was used to hold the plate in place.

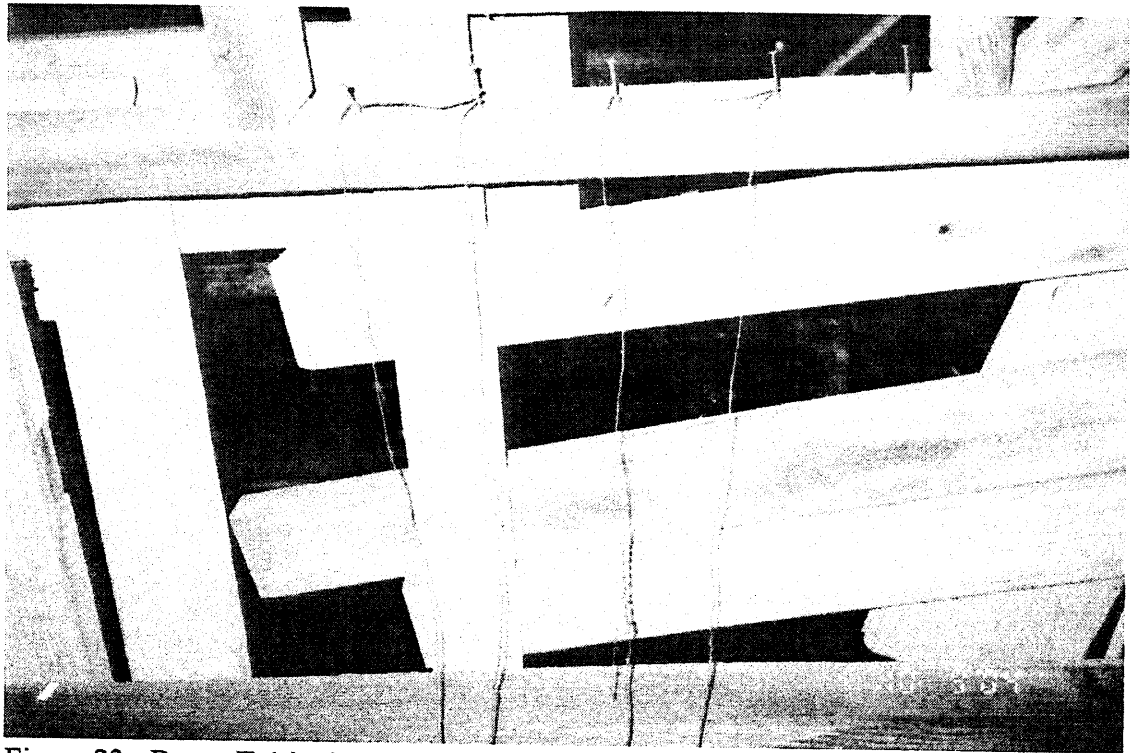
Wire feature - Bailing wire has been spliced to form a long continuous wire. This wire is wrapped around nails that have been placed in the side of the eastern and western most ceiling joists (Figure 23). The wire loosely spans east to west across all five joists, but is only attached to the two joists nearest the walls. It is not known how this had been used. It would not be sturdy enough to hold much weight if it had been used to hang things from.

Figure 23 - Room E-1 in Assay Building. Bailing wire attached to nails in ceiling joist. These wires extended across entire room. Loose old lumber is seen stored above the joists.

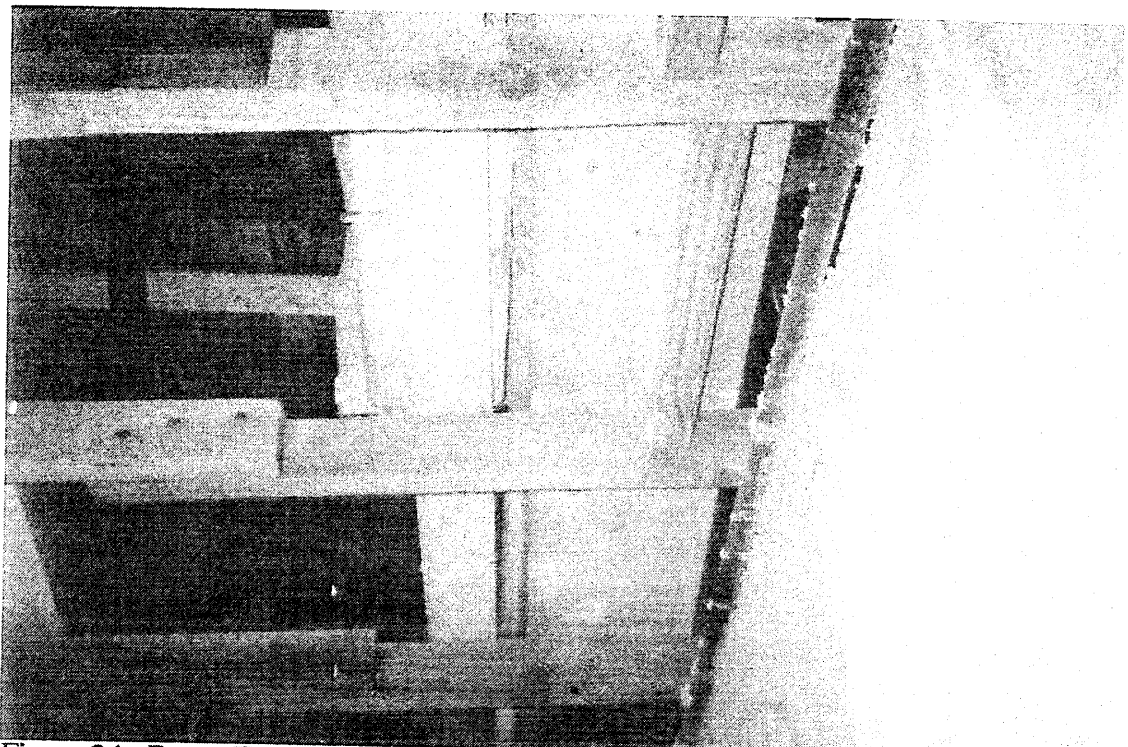
Figure 24 - Room E-1 in Assay Building. Note the 2x4 ceiling joist splices. Dark wood is original.

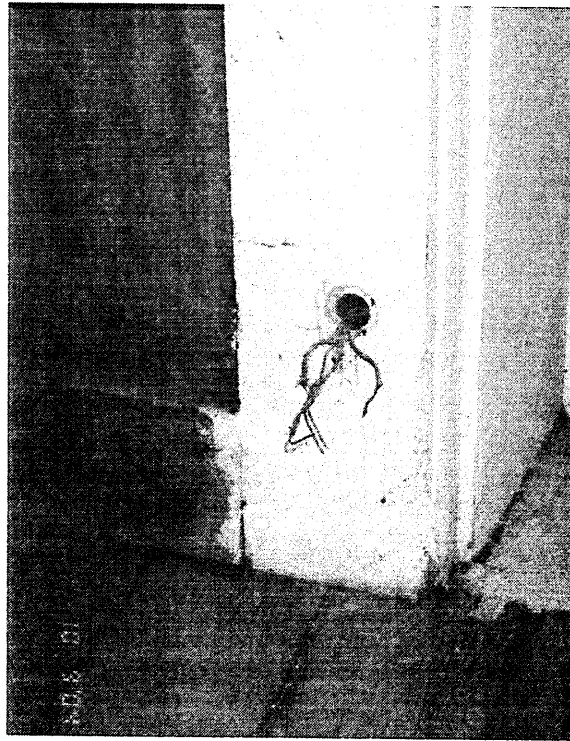
Figure 25 - Room E-1 in Assay Building.  
Telephone wires in door casing.

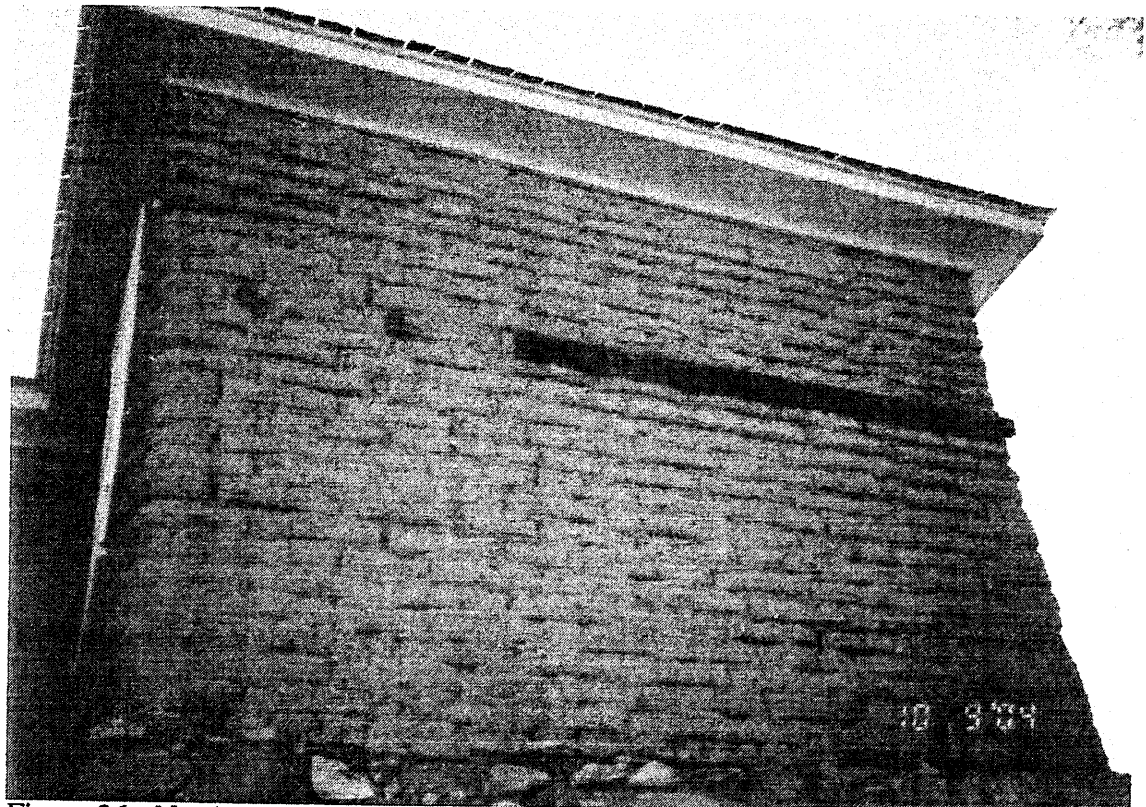
Figure 26 - North wall exterior of Room E-1. 2x4 nailed to gringo boards. This configuration could be similar to the horizontal 2x4 on the west wall of room E-2.

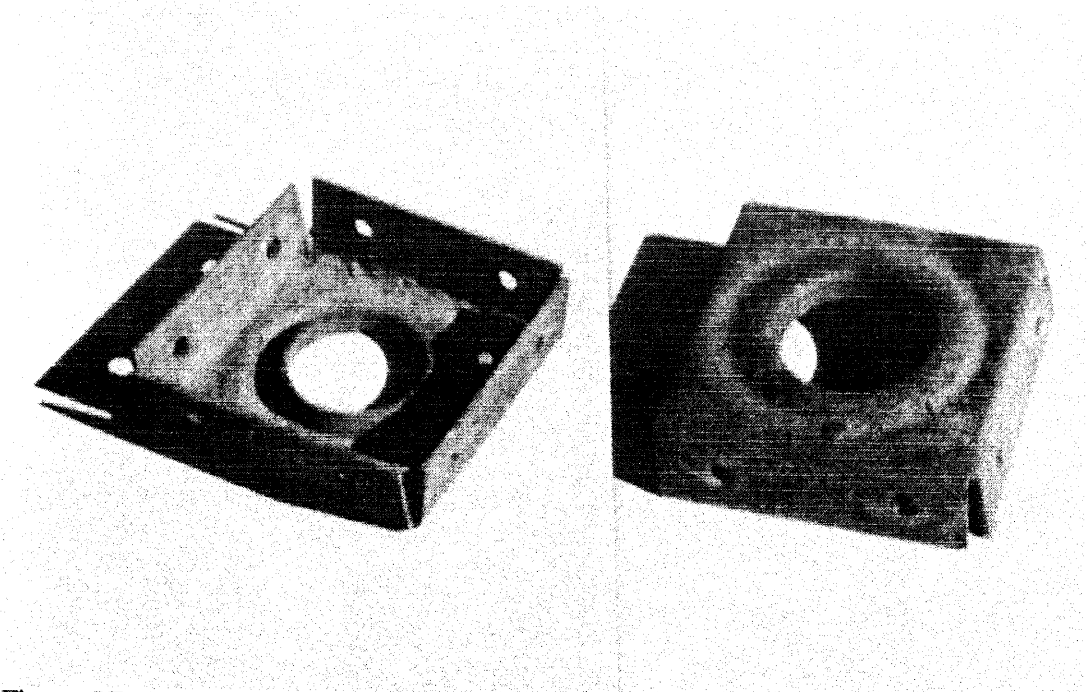
Figure 27 - Top side on left, bottom on right. This metal plate set in the square hole in the floor of room E-2 in the southwest corner.
