# KENTUCKY CAMP CHRONICLE

Newsletter of the Friends of Kentucky Camp

June 1999

## QUICKER THICKER MUD

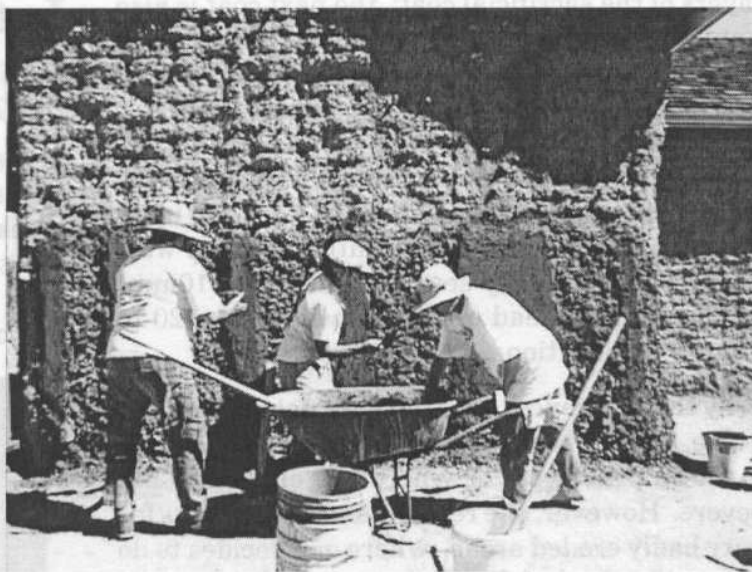
Applying the sacrificial coat.

Third, quick, thick application: The mud was thrown onto the wall surface with a trowel, up to 4 cm thick. Previously, at Kentucky Camp we'd been taught to apply several thin (~5 to 10mm) applications instead of one or two thick (~20 to 40mm) applications.

Why the difference? Martha does not dismiss the value of thin coats where the look of the wall must be preserved, or where the erosion is not severe. However, she recommends thick coats for very badly eroded areas, where one decides to do a "sacrificial coat." Putting on a sacrificial coat is not an easy decision: designed to protect the original wall surface from further erosion, it also hides it from view. Sacrificial coats are most useful where erosion cannot be stopped. For example, we've used them before on the barn ruin, to slow erosion of the original walls. At our cabin, the primary cause of erosion is wind, not rain. The sacrificial coat will protect the original wall from further erosion.

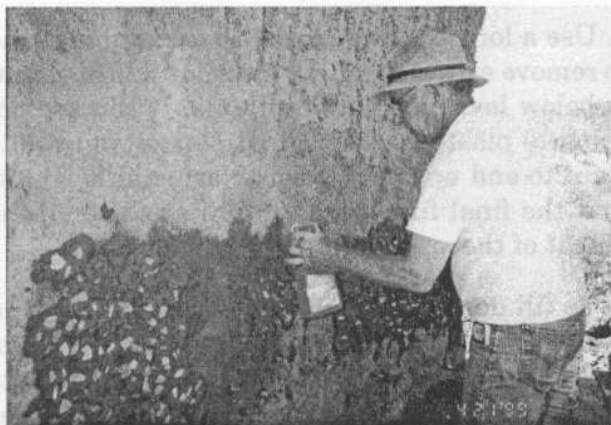
Note the small stones set in the wet mud to anchor the next layer.

layers of the sacrificial coat: the next coat is also applied "soupy" and tends to fill the cracks. For the final coat, the drying is monitored and cracks are repaired, to preclude water penetration.

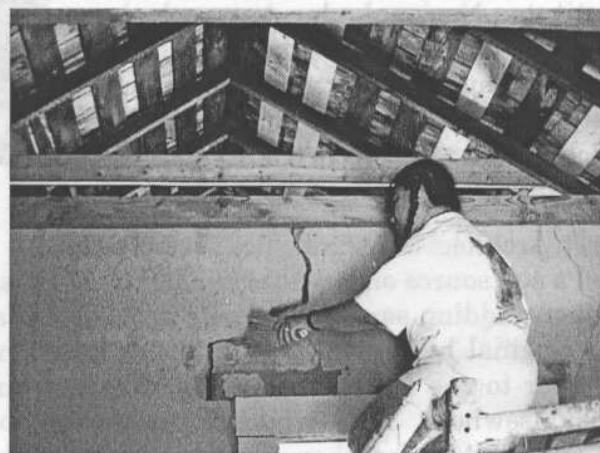
Martha Robles preparing crack for repair.

1. Use a metal cement trowel to remove the loose edges along cracks. Jesus hit the trowel along the crack, chipping off the edges to a point that the plaster remaining on the wall was very solid. He also scraped the loose plaster melt cascading down the wall from erosion above.

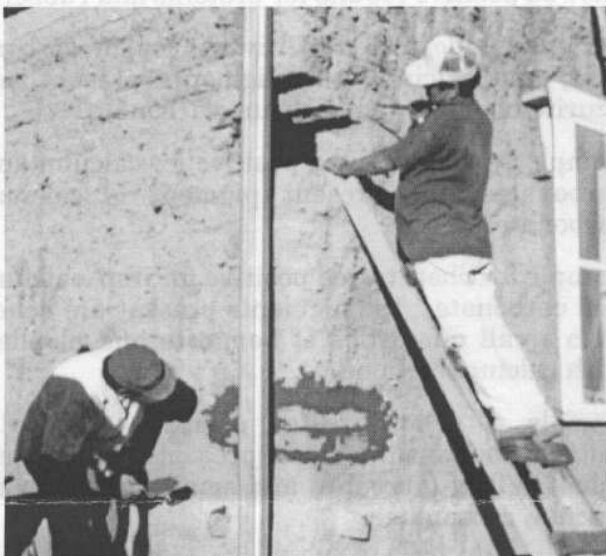
Jesus Robles and Jesus Romero add new bricks to re-bond walls of cabin at eroded corner.

During the work, it became evident that the south wall was no longer interlocked or bonded to the west wall. Martha decided that these walls should be rebonded, or tied together. To do this they removed several original broken bricks in two spots at this corner (Martha explained, through Carlos, that "sometimes you must remove or destroy some original material in order to save the life of the structure"). They removed the corner bricks of courses 8, 9, 18, 19, and 20. New bricks were used in an interlocking manner to bond the walls.

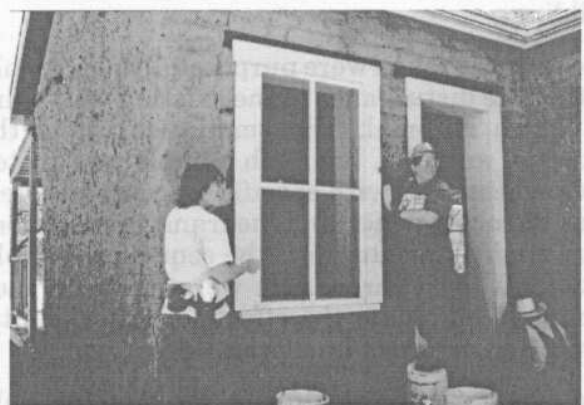
KC Whiteley, Dinah Yessne, and C. Charnley patching walls.

Jim Britton and Susan Jones supervised up to seven volunteers a day during the PIT project in an energetic "mud slinging" campaign. Besides working on the sacrificial coat, discussed above, these volunteers patched cracks, filled holes, and repaired basal erosion. They applied mud and bricks over the bedroom window to keep water runoff from going inside the building. The crew also capped sections of the north and west walls of the barn to repair a crack and hold the wall together, and recorded the major crack above the cabin bedroom door before the INAH team worked on it.

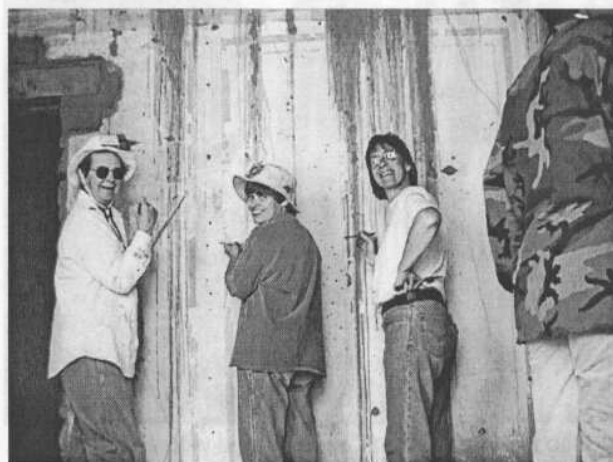
Verla Peter, Susan Jones, and KC Whiteley cleaning eroded mud off the painted surface.

1. *Cleaning of the surface.* This involved using small delicate painters' spatulas to very carefully remove mud that had run down from above to cover the painted surface, as well as the brushing of loose dirt from cracks and eroded areas.

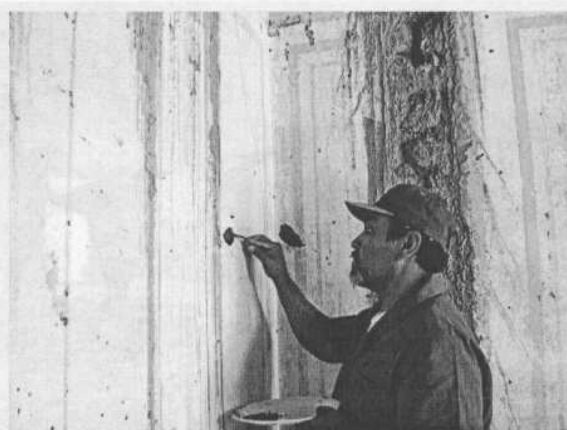
Jorge Morales using a spatula to fill cavities.

2. *Consolidation of the fine earth plaster layer.* Where the original earth plaster had eroded away, finely screened mud plaster was carefully applied to restore the original surface plane. In many cases, the eroded areas were too small to use regular masonry trowels or to "throw" the plaster, so painters' trowels and spatulas were used to apply the plaster, and a polishing stone was used to burnish the edges and blend the new with the old. In some areas, the original mud plaster appeared too weak to be repaired; in these areas, a dilute lime mixture was applied to strengthen the surface before the final earthen

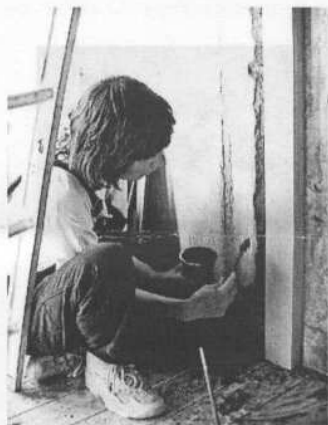
C. Charnley fixing eroded areas.

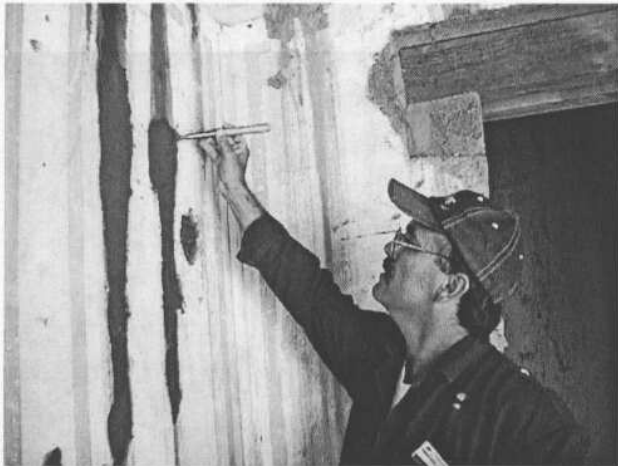
Rodolfo del Castillo using a tool tipped with an agate polishing stone to burnish edges of patch.

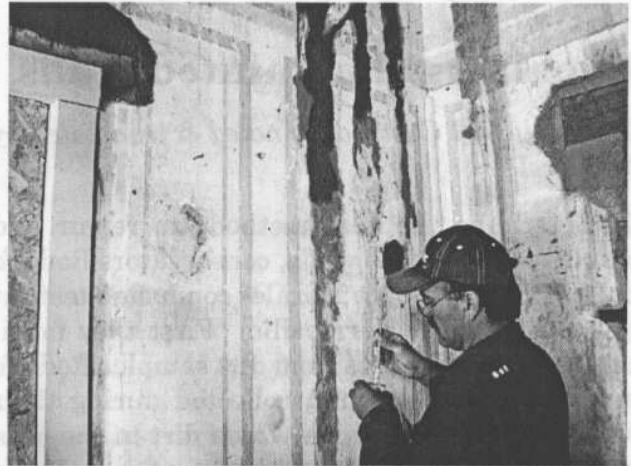
Testing whitewash paint thickness and application.

3. *Restitution of the lime plaster and whitewash,* where necessary. Pre-slaked lime for this process was provided by Ray Madril and Gus Martinez of Tumacacori National Historic Park. Pure lime plaster proved to be too white, so a little dirt was added to better match the existing walls, which have turned creamy with 100 years of dirt.

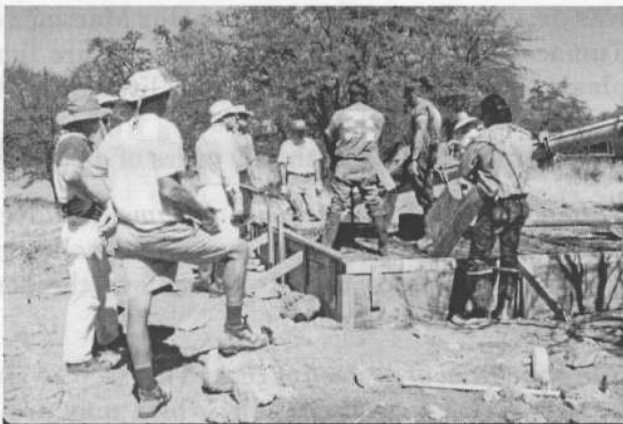
1. Workers stand by as concrete is readied.

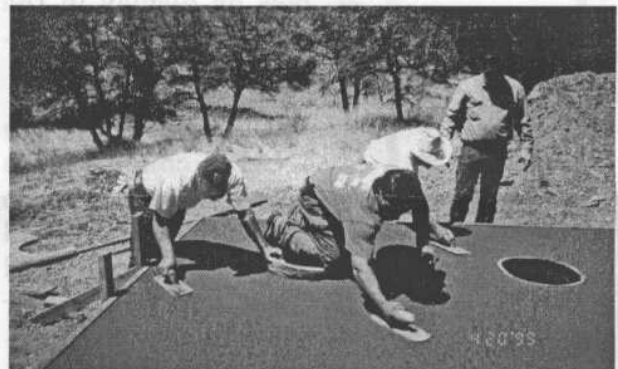
2. Floating the pad for the structure.

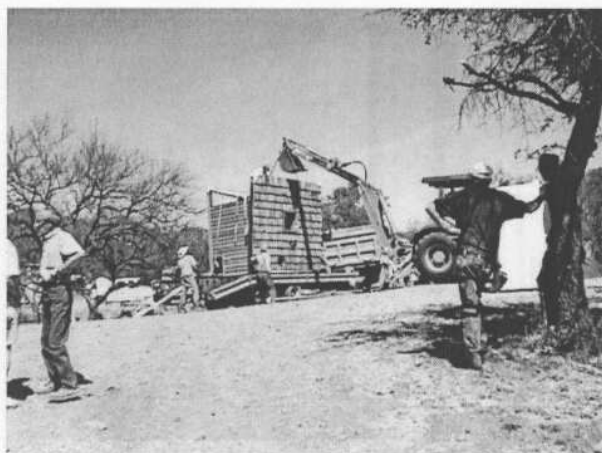
3. Backhoe prepares to set structure on pad.
