**KENTUCKY CAMP**  
**ASSAY BUILDING**  
**INTERIOR DOCUMENTATION**

For the Coronado National Forest  
Tucson, Arizona

November, 2004

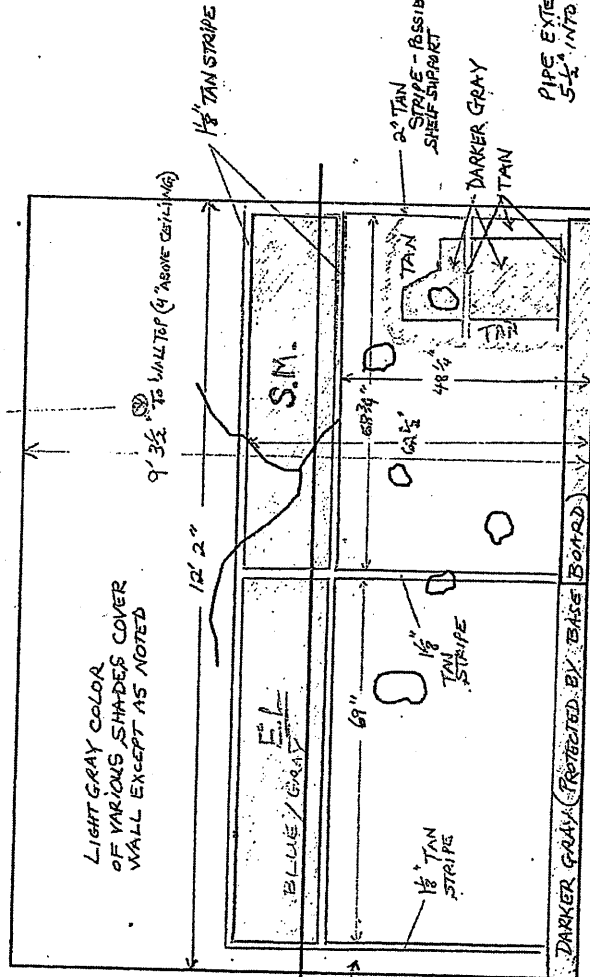
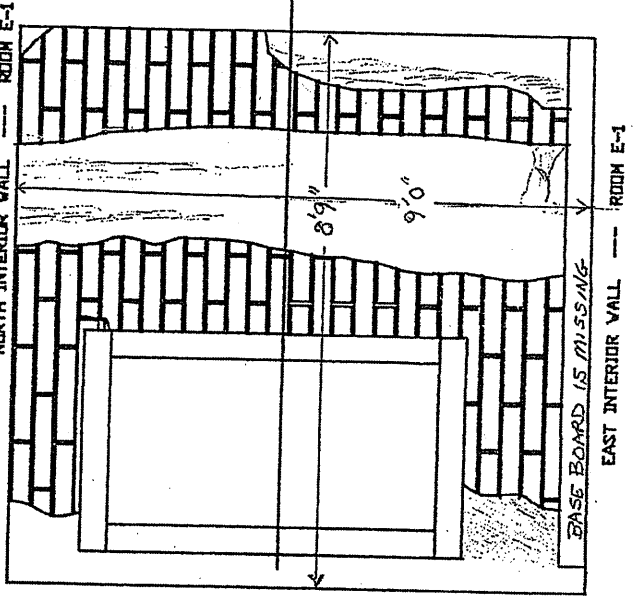
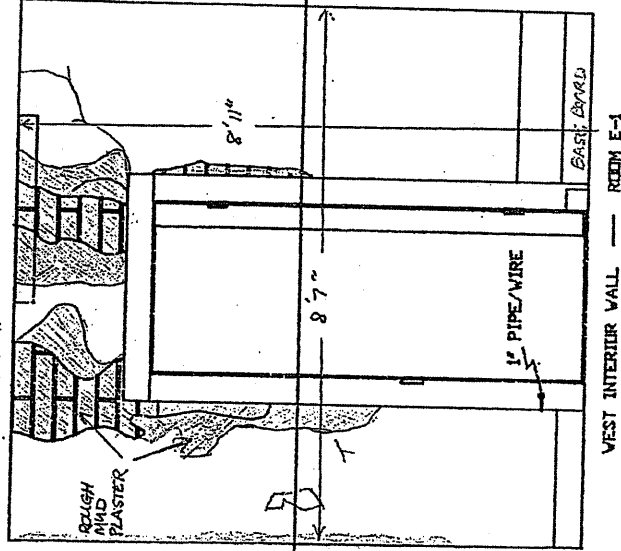
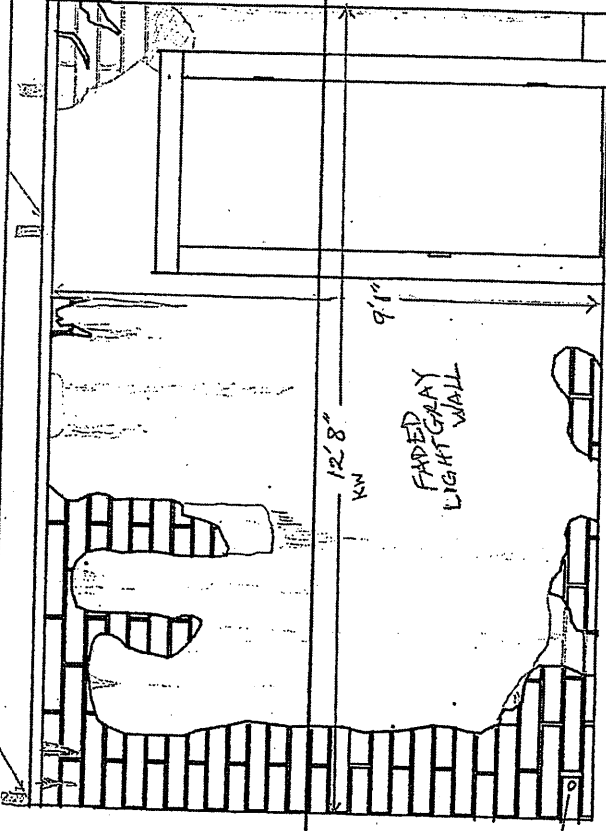
⑧ CEILING JOISTS SET INTO WALL TOP  
MANTA WOODSTRIP IS NAILED TO BOTTOM  
OF JOIST 4" BELOW ABOVE WALL TOP

WOOD  $\frac{3}{4}$ " X  $\frac{3}{4}$ " NAILED TO CEILING JOIST  
TO HOLD MANTA MATERIAL IN PLACE  
THERE WAS A SMALL PIECE OF MANTA  
BETWEEN THESE JOISTS AND MANTA STRIP.

ALL FOUR WALLS SHOW EVIDENCE OF A  
LIGHT GRAY COLOR WHERE ORIGINAL PLASTER  
STILL REMAINS IN PLACE.

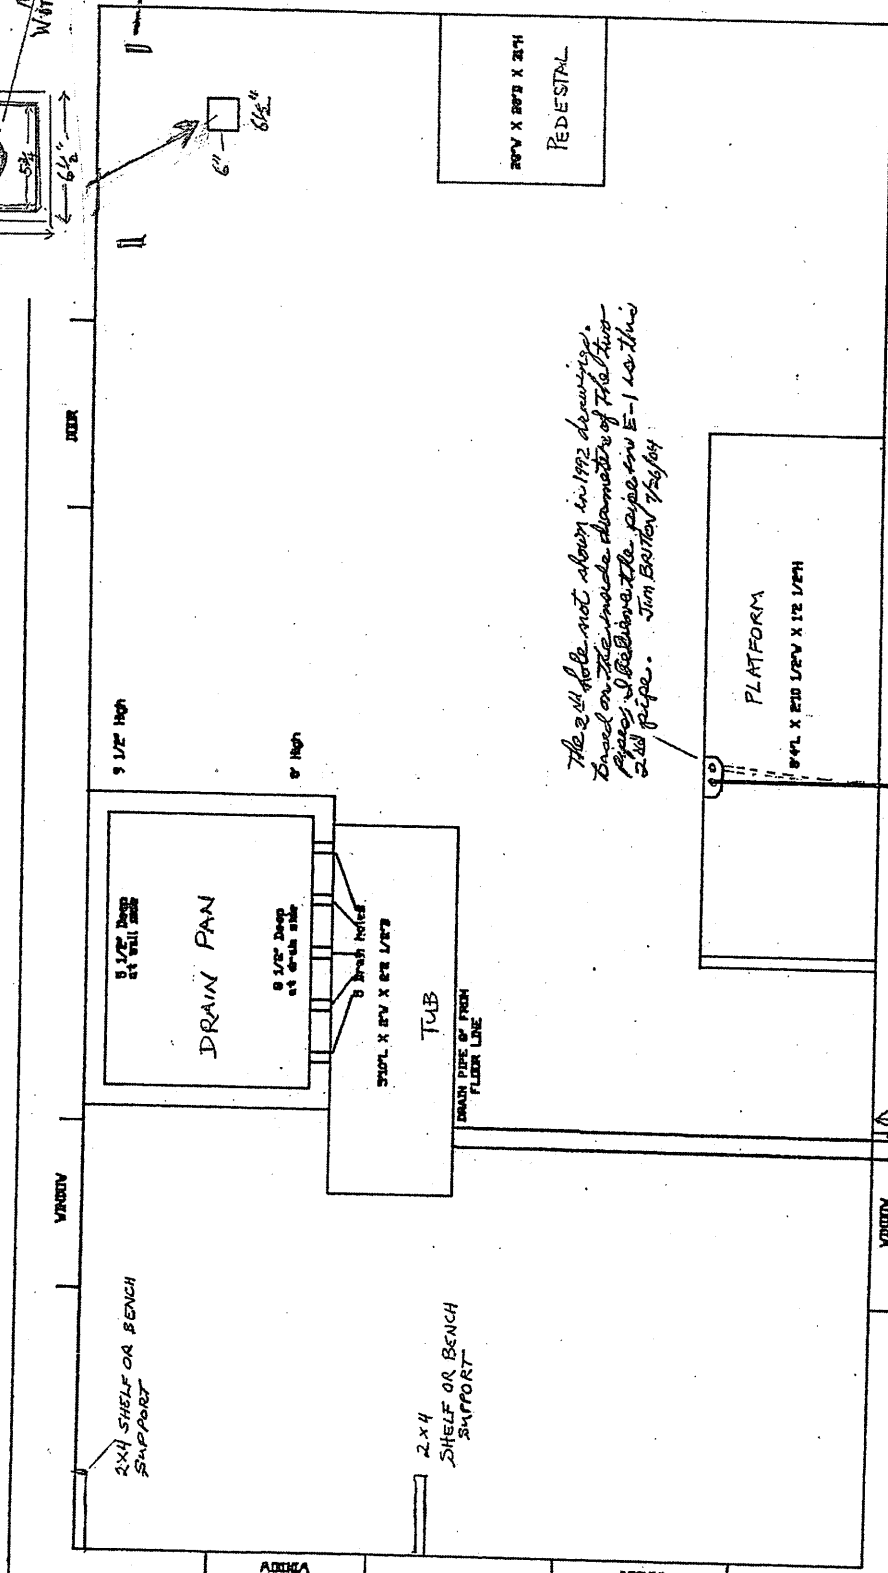
METAL PLATE  
WITH ROUND OPENING

IMPRESSIONS  
IN CEMENT  
FLOOR

The 2 1/4" hole not shown in 1992 drawings.  
Based on the inside diameter of the first  
piece of pipe in the pipe in E-1 to this  
2nd pipe. Jim Batten 7/5/04

SHALL PIPE APPROX 2 1/4"  
EXTENDS INTO ROOM E-1
